# ReSoil

Remediation case #3

Reclamation of heavy metal contaminated  
soil for vegetable production in city of  
Celje, Slovenia

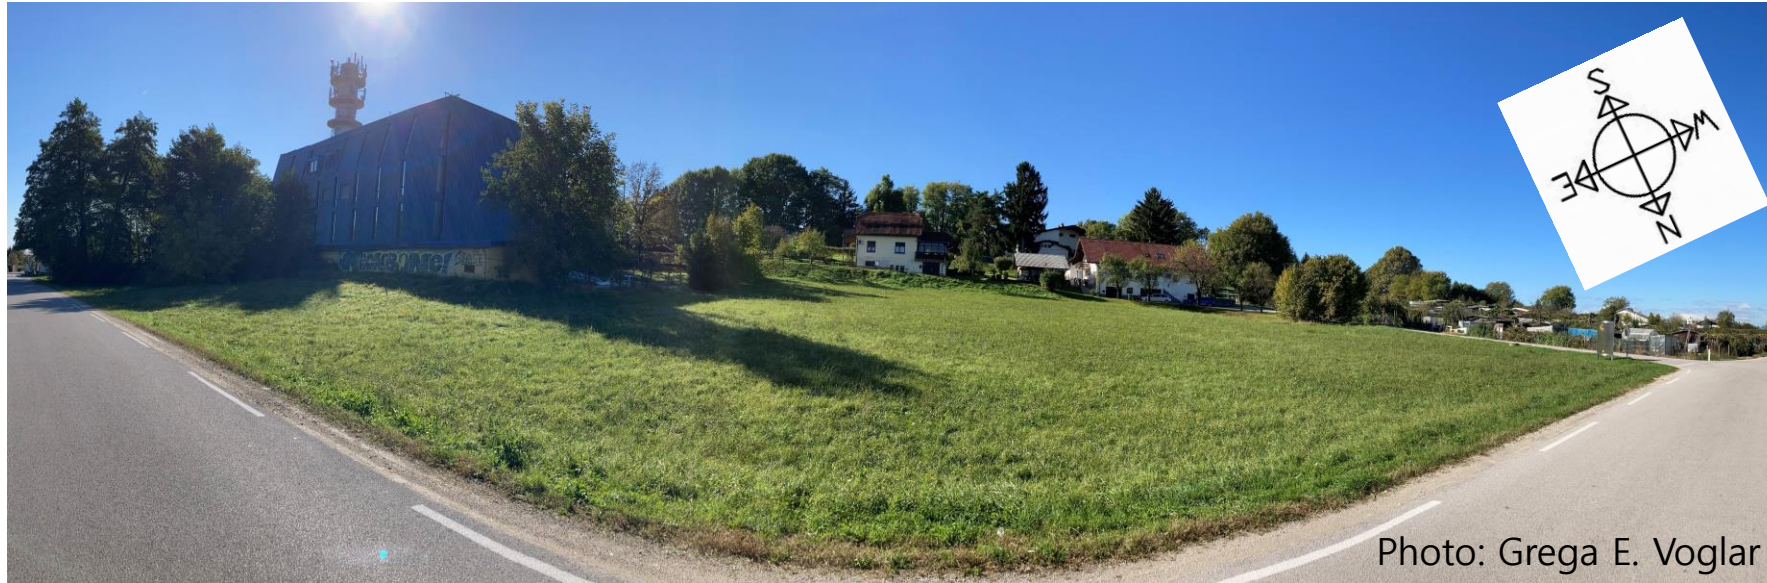
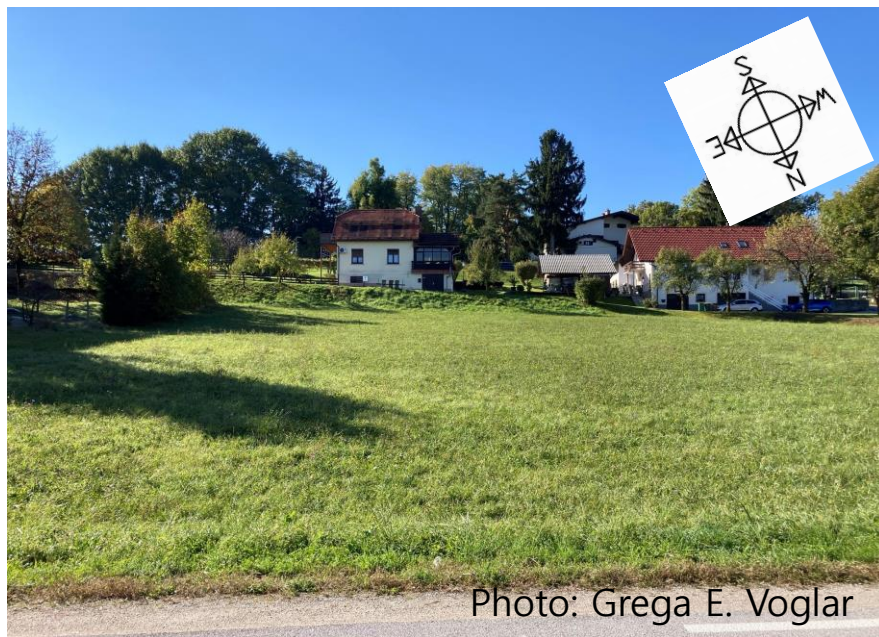
The area is located in the northern part of Golovec, along Samova ulica on plot no. 915/1, cadastral municipality of Lower Hudinja, near Central stadium. The area of the whole plot measures about 5100 m<sup>2</sup>. Since the eastern part, between Samova ulica and the business building, is narrow and steep, the actual usable area is 3760 m<sup>2</sup>. The current area of use is natural meadow with a slight slope to the south. On the south side, near the bank, the terrain is steeper at first, then the slope decreases. The height difference is about 5 m.

Orto-photo of the plot no. 915/1 with locations of sampling points (S1-S7).
