# ReSoil

Remediation case #3

Reclamation of heavy metal contaminated  
soil for vegetable production in city of  
Celje, Slovenia

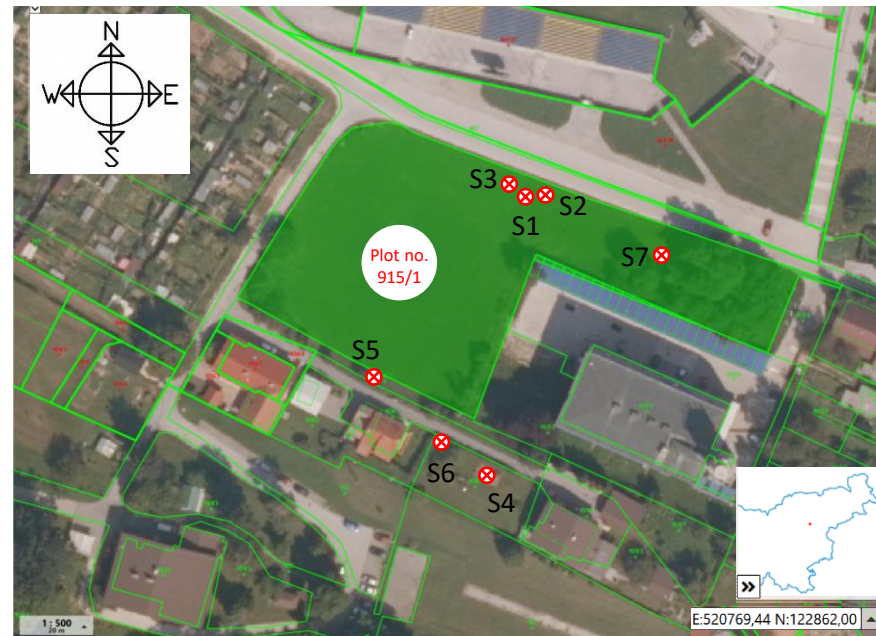
Orto-photo of the plot no. 915/1 with locations of sampling points (S1-S7).

The area is located in the northern part of Golovec, along Samova ulica on plot no. 915/1, cadastral municipality of Lower Hudinja, near Central stadium. The area of the whole plot measures about 5100 m<sup>2</sup>. Since the eastern part, between Samova ulica and the business building, is narrow and steep, the actual usable area is 3760 m<sup>2</sup>. The current area of use is natural meadow with a slight slope to the south. On the south side, near the bank, the terrain is steeper at first, then the slope decreases. The height difference is about 5 m.

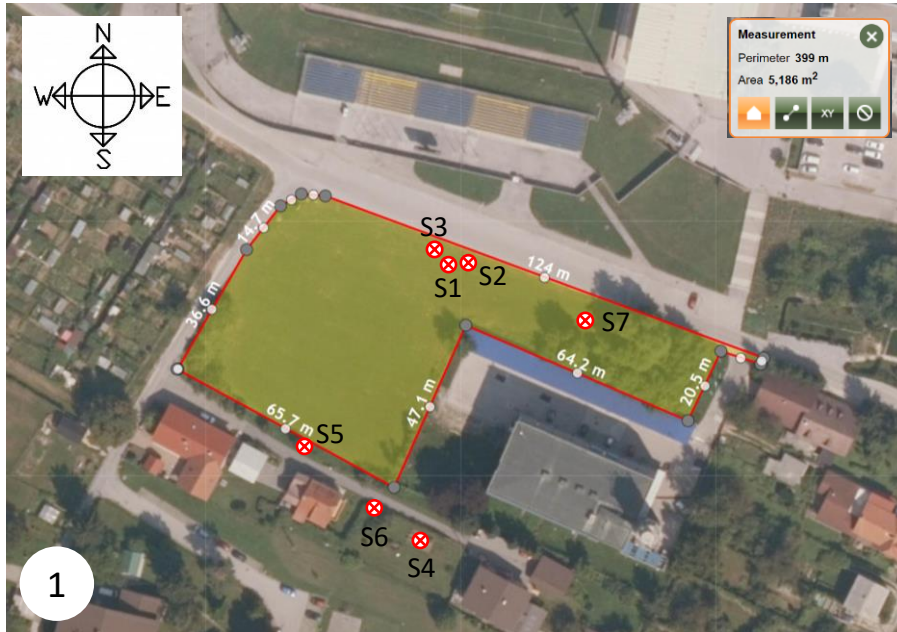
Allocation of sampling points at ReSoil® demonstration site 915/1.

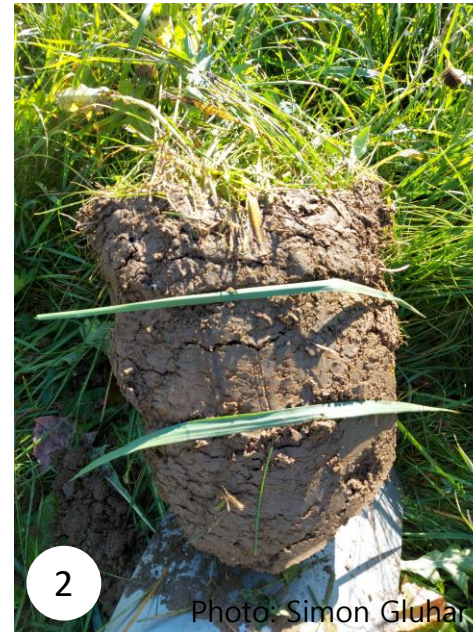
Soil profile at sampling point S1.

Soil properties:

- silty clay type of soil,
- 4.3% of organic matter
- C/N ratio 10.9

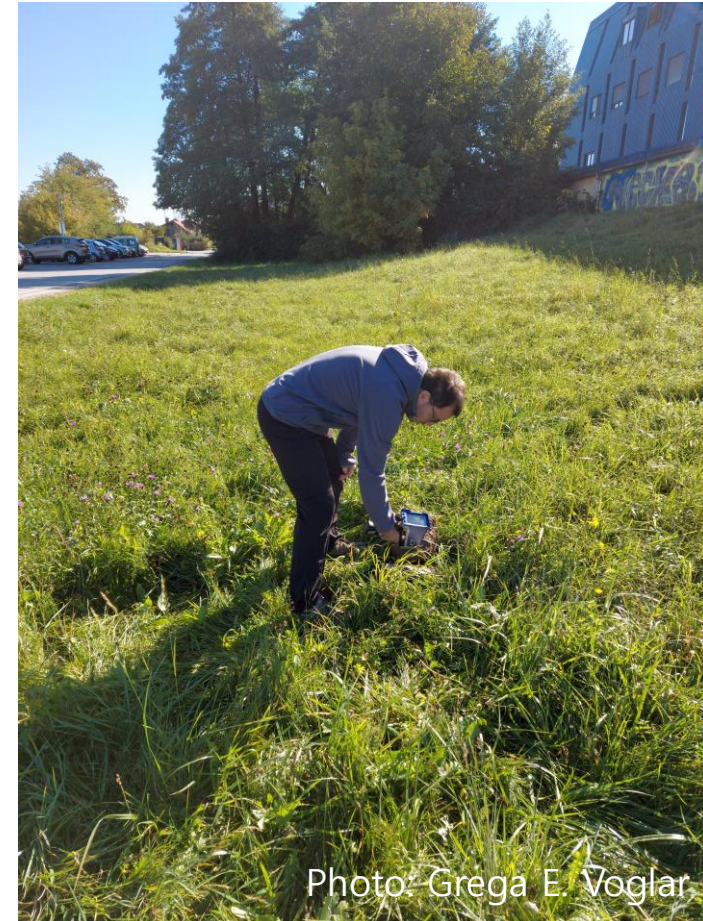
We performed soil analysis using handheld X-Ray Fluorescence analyser (XRF). The soil sample from a sampling point (S1) was combined with the soil sample of three soil horizons / depths.
