## The Study Case #2 – ReSoil<sup>®</sup>-Agro in Arnoldstein/Tulin, AUSTRIA

#### TRADITIONAL LEAD SMELTER, ARNOLDSTEIN, AUSTRIA

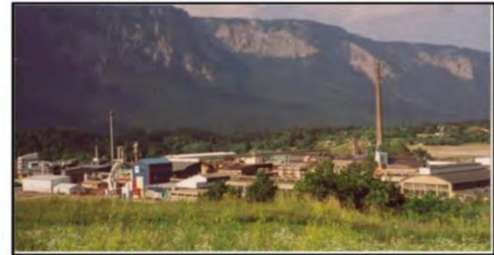
A large lead smelter and a lead recycling plant that contributed to high lead exposure in the area – Drach, 2000
