The Study Case #1 – ReSoil[®]-Urban in Prevalje, SLOVENIA

Objective

Production of safe vegetables on remediated soil

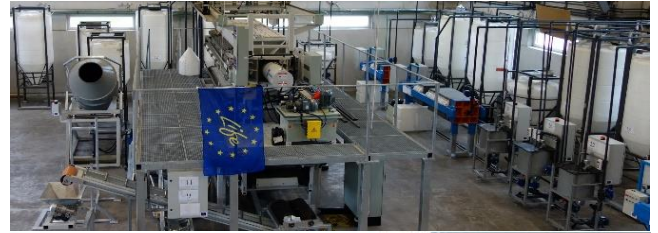
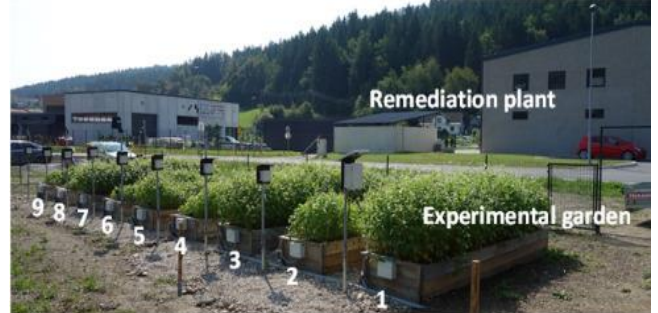
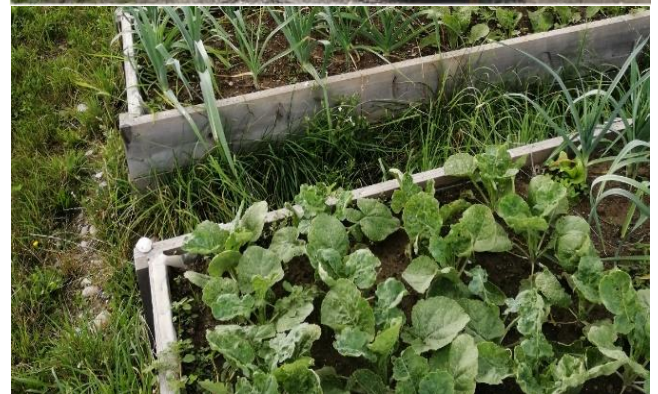
Remediation results

- No hazardous leachates from the soil
- Plants with rich root system is needed to restore the natural structure of the soil
- After a year of growing vegetables there were no differences in physical, chemical and biotic properties between the remediated and original soil
- Plant uptake of Pb and Cd was reduced by up to 95 and 91 % respectively

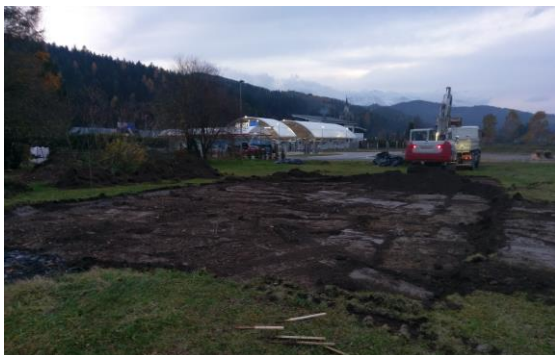
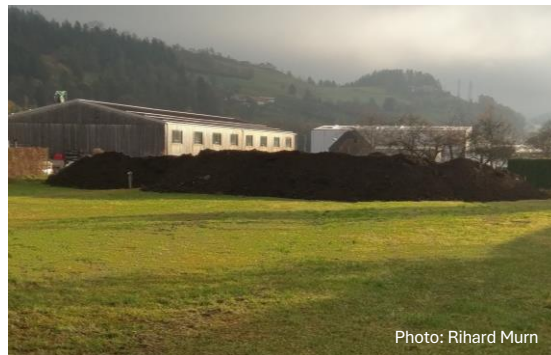
Contaminated site

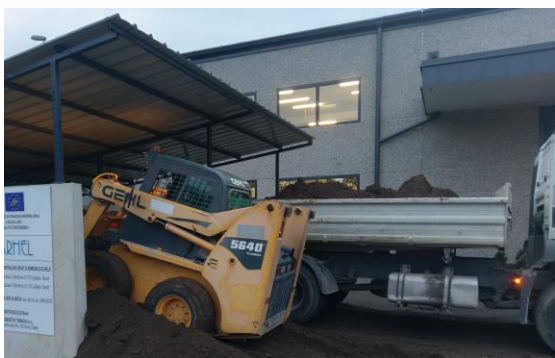
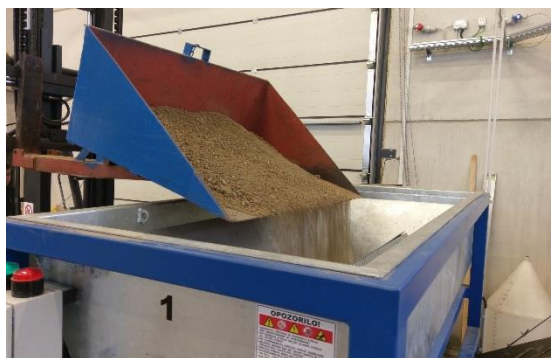
Soil transportation to ReSoil[®] remediation plant

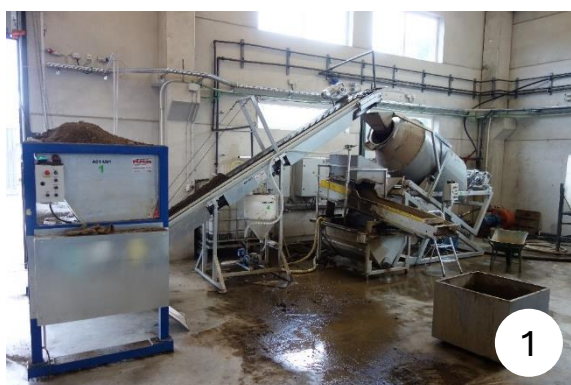
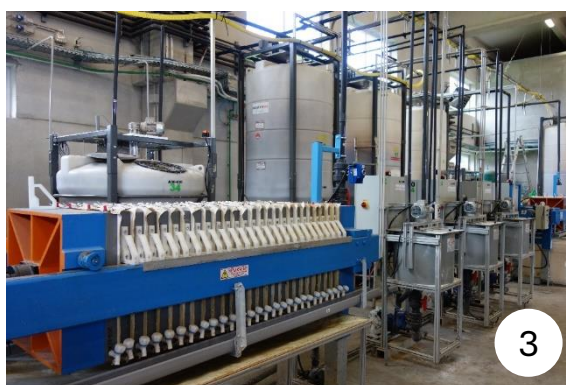
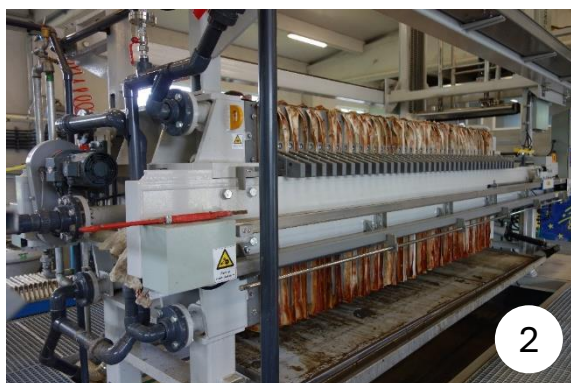
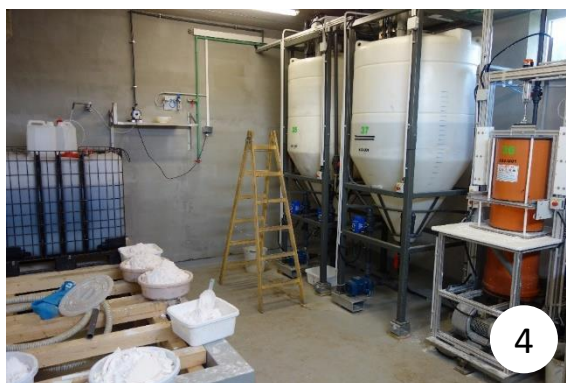
In the remediation plant

1. Soil washing
2. Soil rinsing, separation
3. EDTA, water recycle ...alkaline phase
4. EDTA, water recycle ...acidic phase
